Subject: On-Call Asbestos, Lead, Air Quality & Demolition Compliance
Agreement No.: 8.07-01 (18)
HazMat Inspection – Bridge No. 01659, SR 712 over Housatonic River, Derby/Shelton, CT
ConnDOT Assignment No. 519-6060
ConnDOT Project No. 126-174
TRC Project No. 289951.6060.0710

TRC performed a limited survey for hazardous building materials associated with the rehabilitation of Bridge No. 01659, SR 712 over the Housatonic River in Derby/Shelton, Connecticut. Bridge No. 01659 is constructed entirely of unpainted concrete except for a small portion on the NE corner which had some grey graffiti cover-up paint that had non-detectable levels of lead. Since the paint had non-detectable levels of lead, any paint waste would be non-hazardous, non-RCRA waste. White fence caulk, light grey pipe packing, grey fibrous pipe insulation with tar coating, black tar in bridge wall and black sidewalk tar were sampled and found to contain no detectable levels of asbestos. Potential universal waste (UW) (LED light poles with printed circuit boards) was identified on the topside of the bridge. No bird/pigeon guano accumulations or bloodborne pathogen concerns were identified at Bridge No. 01659.

Site Na

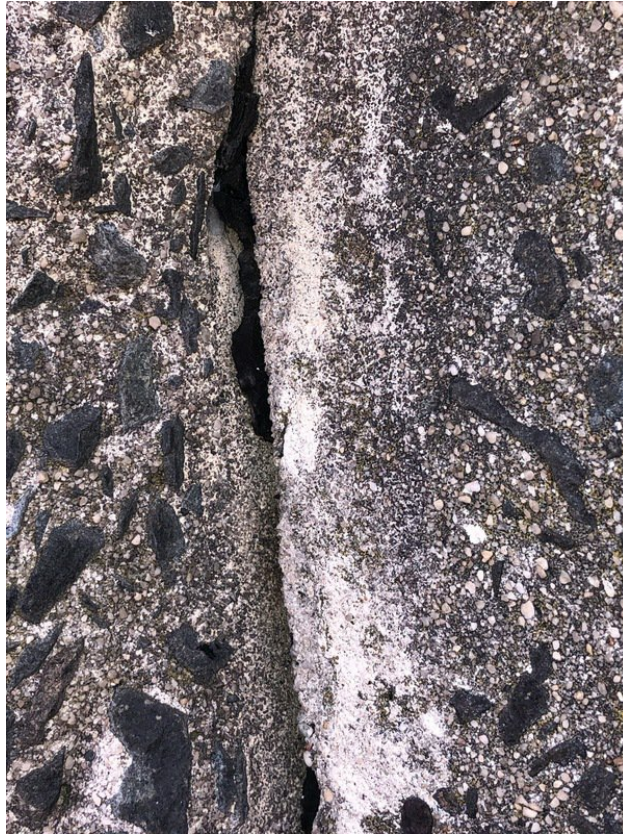
(2), T 1, Black tar in bridge wall, 2

South bridge wall

North bridge wall

Sampled or Assumed?	Sampled
Material Acronym	T 1
Material Description	Black tar in bridge wall
Is Material a Non-Friable Organically Bound (NOB)	Yes
Homogeneous Area	Bridge walls
Total Approximate Quantity	15 LF
Total Count	(2)
Total Count (number only)	2

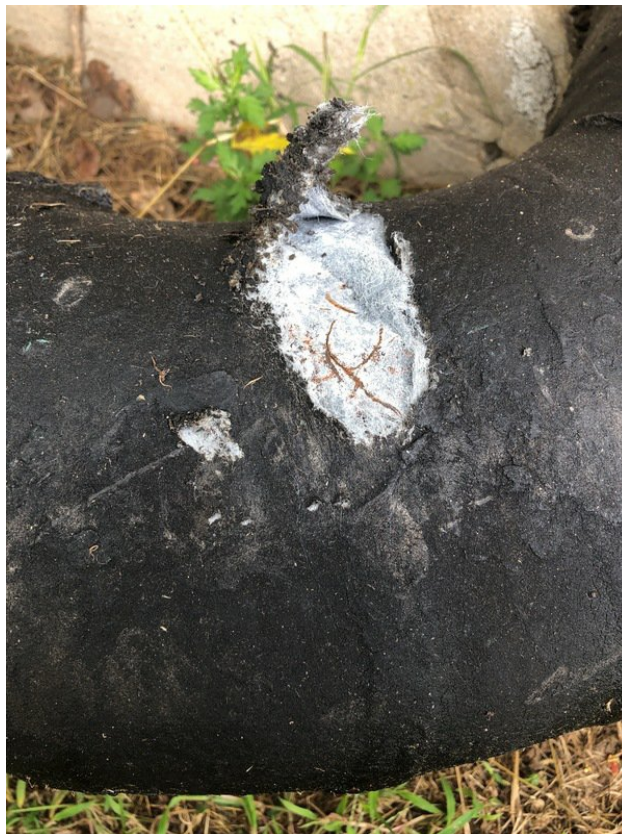
(3), Pl, 1, Grey fibrous pipe insulation with black tar-like top layer, 3

East end of bridge

Material Acronym	PI, 1
Material Description	Grey fibrous pipe insulation with black tar-like top layer
Is Material a Non-Friable Organically Bound (NOB)	Yes
Homogeneous Area	All along pipe on south side of bridge
Total Approximate Quantity	~250 LF
Total Count	(3)
Total Count (number only)	3

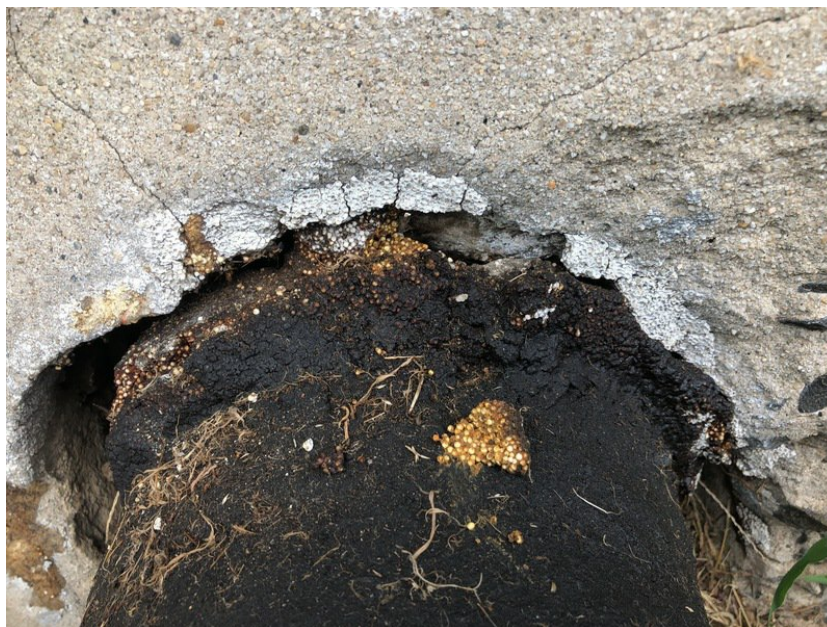
(2), FP, 1, Light grey flu packing, 2

East end of bridge

Sampled or Assumed?	Sampled
Material Acronym	FP, 1
Material Description	Light grey flu packing
Is Material a Non-Friable Organically Bound (NOB)	No
Homogeneous Area	East end of bridge at end of pipe

Total Approximate Quantity	~2.5 LF
Total Count	(2)
Total Count (number only)	2

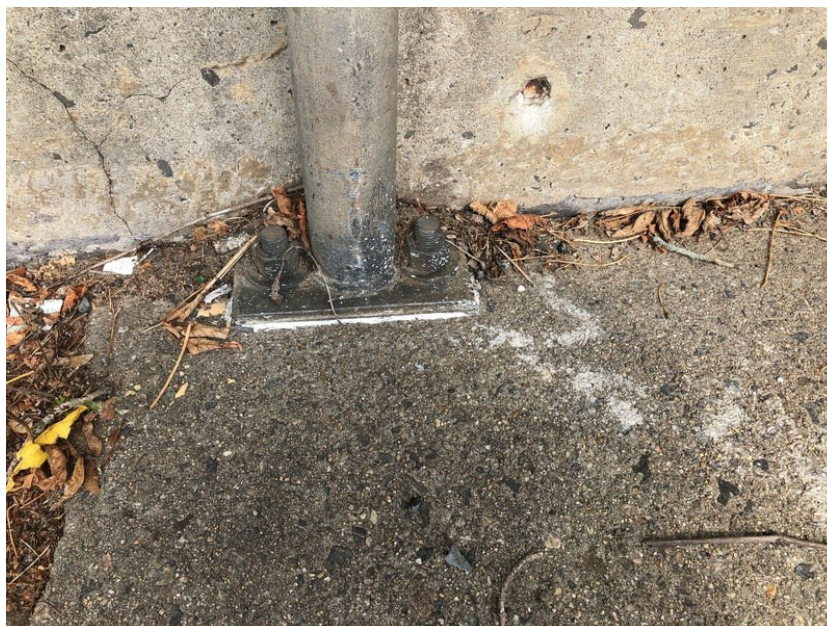
(2), C, 1, White fence caulk, 2

East end of bridge

West side of bridge

Sampled or Assumed?	Sampled
Material Acronym	C, 1
Material Description	White fence caulk
Is Material a Non-Friable Organically Bound (NOB)	Yes
Homogeneous Area	Under fence posts
Total Approximate Quantity	18 LF
Total Count	(2)
Total Count (number only)	2
